The 1906 San Francisco Earthquake and Fire Online Exhibit

Room Two: The Day Our City Trembled

Bad Construction

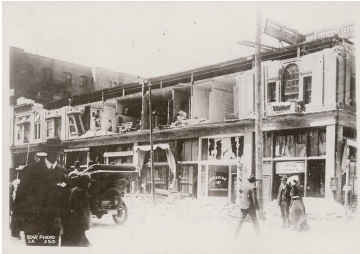
[Earthquake damage to dwellings and storefronts. Larkin and Turk Sts.]
Bear Photo Co. no. 250. Vol. 1:112a

While much of the most horrific earthquake destruction occurred on the made land South of Market, there were many structures that rested on more solid soil that also experienced significant damage. This scene at the corner of Larkin and Turk Streets, north of Market Street, shows how poor bricklaying held up against the earthquake's tremors. The second-story brick façade has peeled away, causing the apartments to look like rooms in a doll house as their arranged contents are revealed to passerby on the streets below.
